RAILWAY INVESTIGATION REPORT

R02Q0041

DERAILMENT

CANADIAN NATIONAL
YARD ASSIGNMENT NUMBER 1600
MILE 115.2, MONTMAGNY SUBDIVISION
LÉVIS, QUEBEC
22 JULY 2002

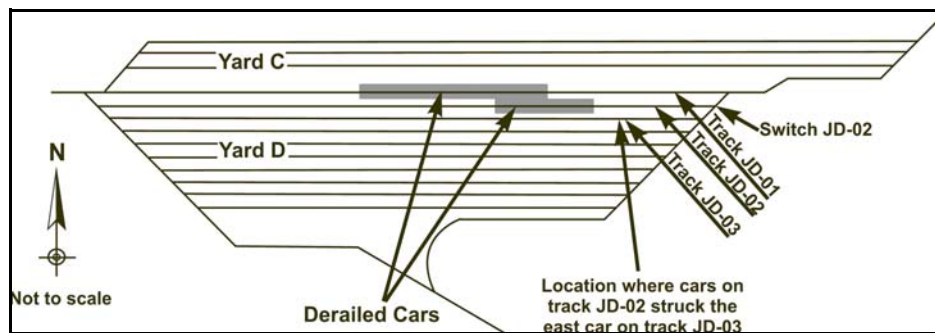
Figure 1. Layout of Joffre Yard

On 22 July 2002 at approximately 2000 eastern daylight time (EDT),¹ the Joffre Yard crew, operating yard assignment No. 1600, went back to work following a break during severe weather conditions. Using a belt pack-controlled yard locomotive, several short cuts of cars were sorted onto track JD-02 (see Figure 1) through the west switch, shoved eastward to couple onto a cut of 30 cars, then pulled and brought to a controlled stop. As the cars stopped, the crew heard a loud noise and observed the cars they were coupled to, as well as the cars on the adjacent track, JD-01, rolling over and derailed. They advised the yard supervisor of the accident and performed the necessary emergency procedures. The crew determined that 34 tank cars on track JD-01, and 17 tank cars and 1 bulkhead flatcar on track JD-02, were derailed. The tank cars, all equipped with permanently locked shelf couplers, were lying on their side; the bulkhead flatcar was upright. There were no injuries and no product was spilled.

An inspection of the accident site revealed fresh wheel rim markings on the JD-02 east switch frog and on the ties beginning at the heel block of the JD-02 east switch and continuing westward for about 830 feet along the lead track through the JD-03 east switch and into track JD-03. The switch points of the JD-02 east switch showed signs of having been run-through. The ballast between track JD-02 and track JD-03 was disturbed. A roller from a truck side bearing was found approximately 60 feet west of the JD-02 east switch frog.
